# **ETAS ES820.1**

## **V7.5 Service Pack 4**

### **Release Notes**

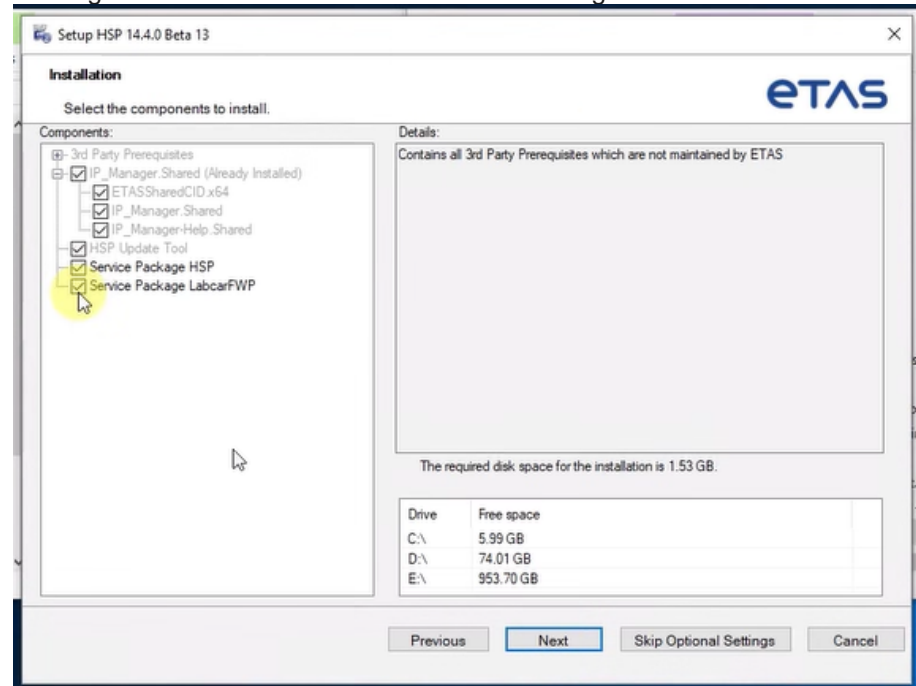
HSP V14.3.0 FW package not installed due to insufficient storage.

Due to insufficient disk space on drive C, HSP must be installed on the D drive of the ES820.

With HSP V14.4.0 installation, the data directory can be changed to the D drive of the ES820 to overcome the lag of insufficient disk space on the C drive.

To ensure that the installation of HSP V14.4.0 or later succeeds, at least 6GB free disk space on the target drive are needed. Also the option Service Package LabcarFWP should be deselected during the installation.

To make the data directory changeable, uninstall an existing HSP completely with all the firmware packages. This will remove the registry key "Computer\HKEY\_LOCAL\_MACHINE\SOFTWARE\WOW6432Node\ETAS\HSP\ProductData". Additionally look that are no leftovers in the default directory "C:\ETASData\HSP". In very rare cases the uninstallation cannot delete the complete directory. If the Registry key "Computer\HKEY\_LOCAL\_MACHINE\SOFTWARE\WOW6432Node\ETAS\HSP\ProductData" does not exist and the directory "C:\ETASData\HSP" does not exist, then the data directory can be changed during installation. Then do a fresh install and change the data directory.
